BIRD STRIKE CAPABILITIES OF TRANSPARENT AIRCRAFT
WINDSHIELD MATERIALS. PART II. SUPPLEMENTAL
EVALUATION OF PARAMETERS AFFECTING MATERIALS RESPONSE

Goodyear Aerospace Corporation

AFML-TR-74-234
Part II

Part II. Supplemental Evaluation of Parameters Affecting Materials Response

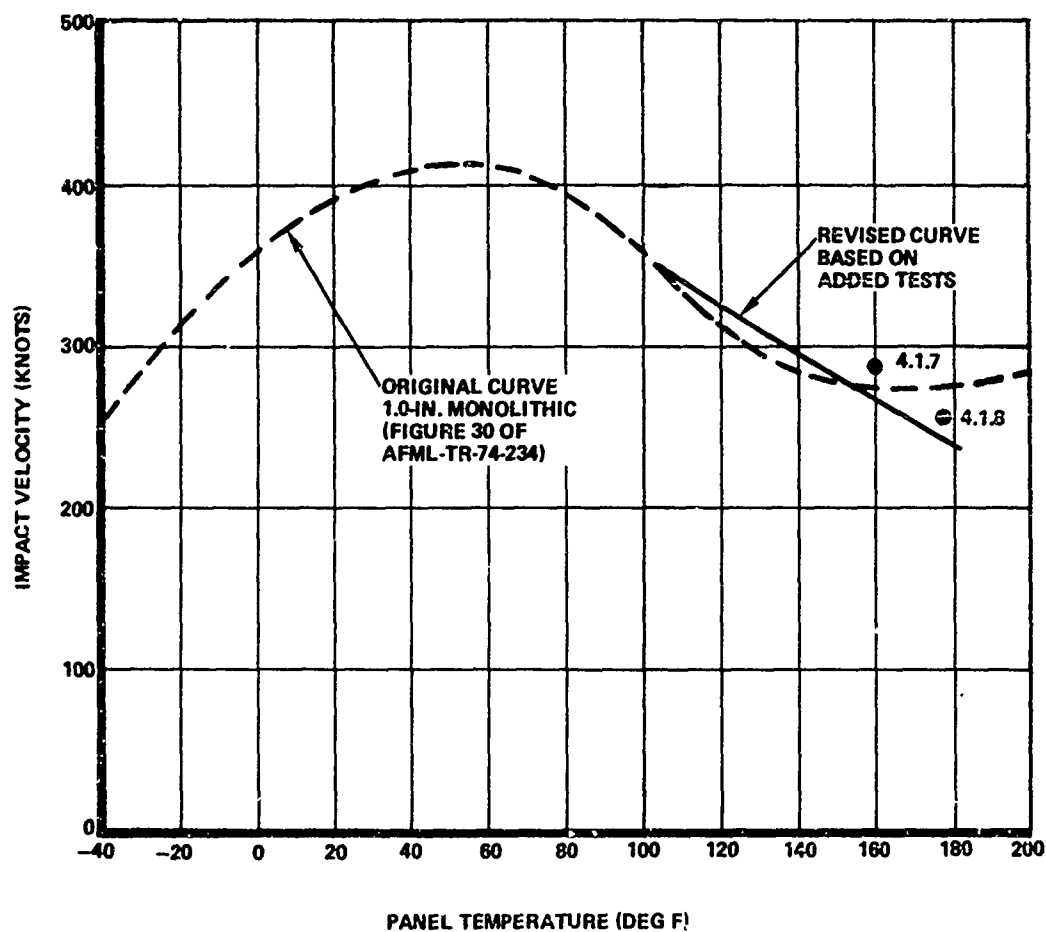
Figure 8. Effect of Panel Temperature on Penetration Velocity for Optically Treated 1.0-In. Monolithic Polycarbonate at 45-Deg Bird Impact Angle

temperature stabilized for at least an hour to assure as uniform a temperature as possible throughout the test panel. The test results as listed in Table 9 showed the expected decrease in penetration velocity with increases in temperature. The higher penetration velocities from the prior test series may have been due to shorter temperature soak cycles resulting in cooler temperatures near the panel center than were indicated by the edge thermocouples. The revised data plot for the effects of temperature on 1.0-in. monolithic polycarbonate flat panels is shown in Figure 8.

A third panel (BD-135 in Table B-15) of this configuration was also tested at an elevated temperature. It showed a penetration velocity substantially higher than that achieved by the room temperature panels, but it was also noted that a number of the attachment bolts in the lower edge of the panel were pulled out by the impact. This may have caused a higher apparent penetration velocity than if the lower edge of the panel had been firmly restrained.

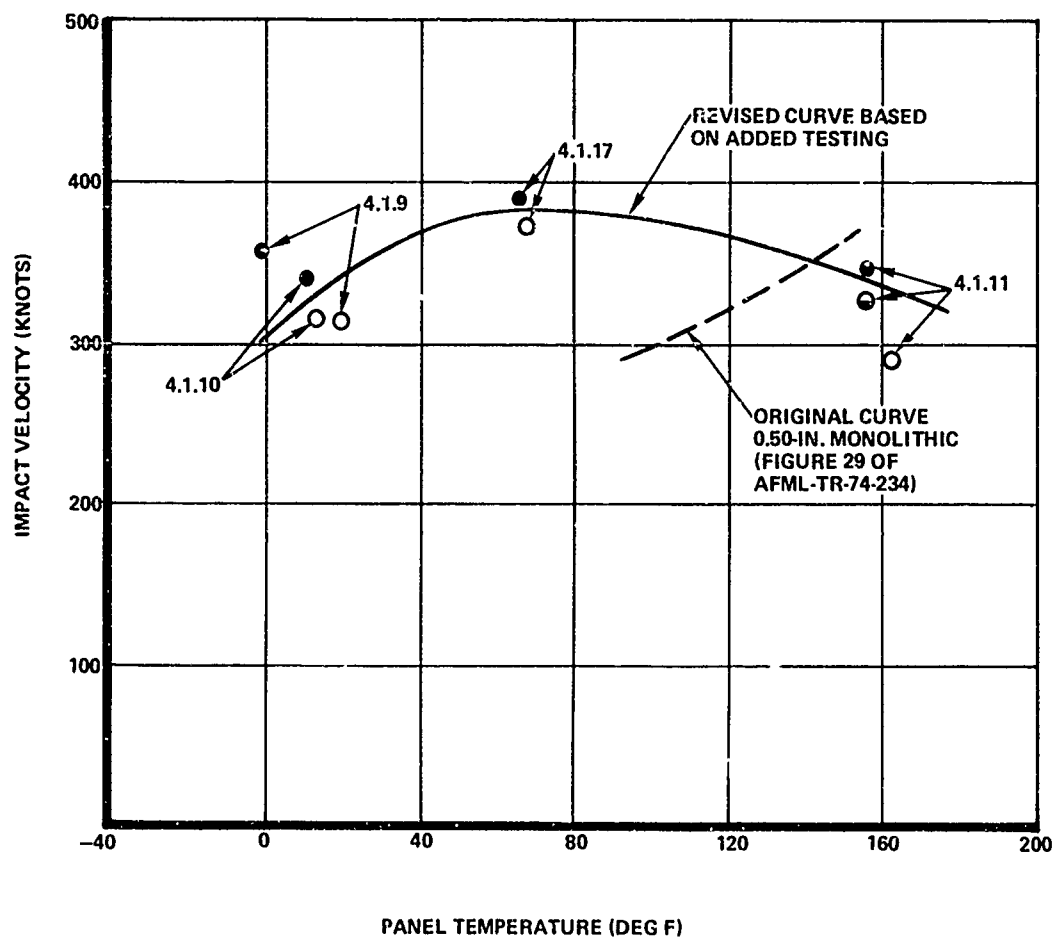
Figure 10. Effect of Panel Temperature on Penetration Velocity for 0.50-In. As-Extruded Polycarbonate at 45-Deg Bird Impact Angle

Figure 10 presents a plot of the data points and shows the revised curve to indicate the penetration velocity for the 0.50-in. as-extruded polycarbonate as a function of panel temperature. The original curve as presented in AFML-TR-74-234 is also shown for reference. The effect of the substantial increase in the penetration velocity at the room temperature point is readily apparent from a comparison of the two curves. The risk involved in attempting to establish a true curve based on a limited number of test specimens is also illustrated by this figure.

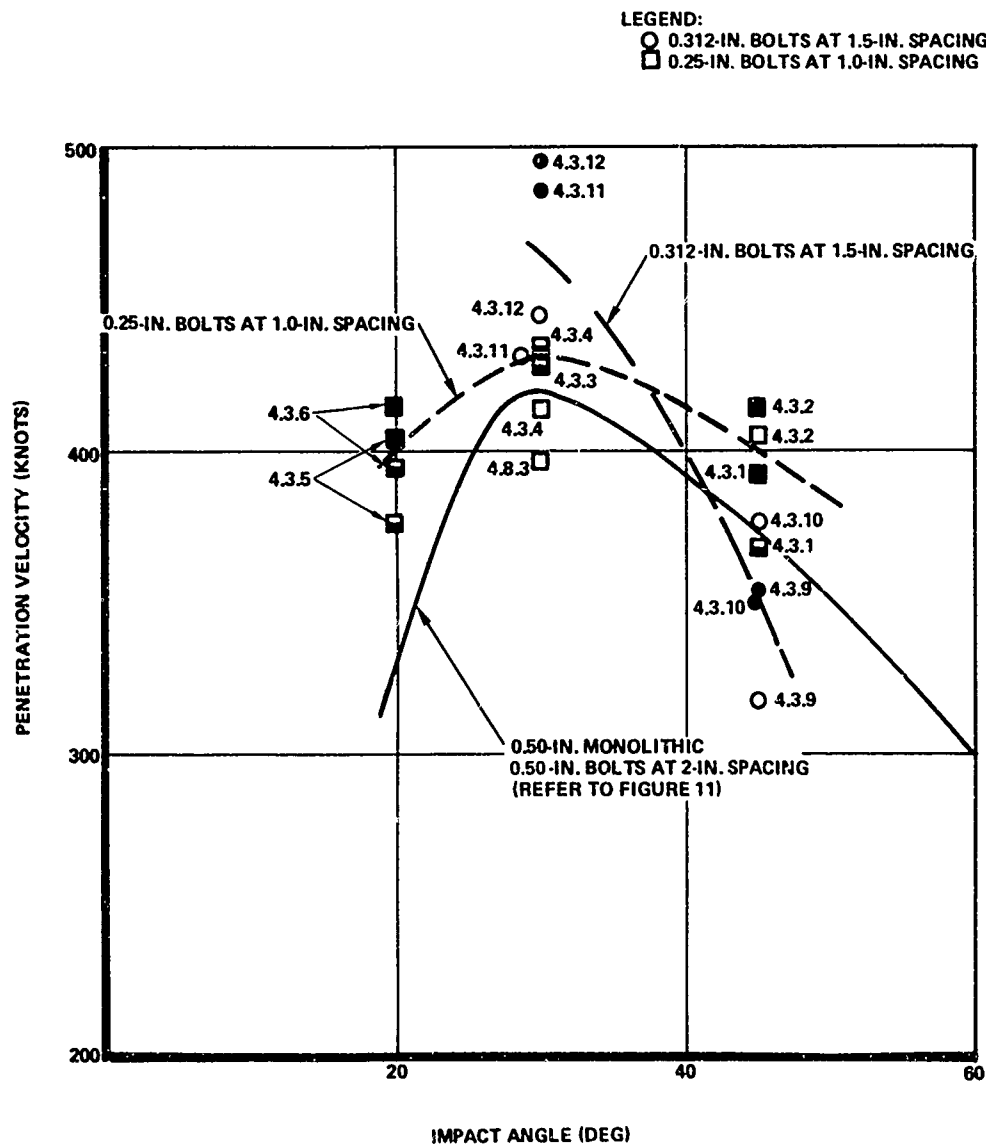
Figure 25. Comparison of Effect of Attach Bolt Size on Penetration Velocity at Various Bird Impact Angles for 0.50-In. Monolithic As-Extruded Polycarbonate

Figure 25 presents the test results for the 0.50-in. panels tested during this series plus the results from the prior tests using the 0.50-in. bolts at 2.00-in. spacing. This figure shows the curves representing the penetration velocities for the panels with the 0.312-in. and the 0.25-in. fasteners. It is apparent from these limited tests that changing the edge attachment bolt size and spacing does influence the penetration velocity. However, the influence also is seen to vary as a function of the impact angle. The 0.25-in. fasteners increase the penetration resistance of the 0.50-in. panels by approximately 20 percent, 3 percent, and 8 percent at bird impact angles of 20, 30, and 45 deg, respectively, when compared against the prior tests with 0.50-in. bolts.

For the 0.312-in. fasteners, the changes in the penetration velocity are not as consistent. At the 30-deg impact angle, the penetration velocity is increased by about 10 percent; but at the 45-deg impact angle, it is approximately 6 percent less when compared with the test panels with the 0.50-in. fasteners. Figure 26 shows panel 4.3.10 after test.

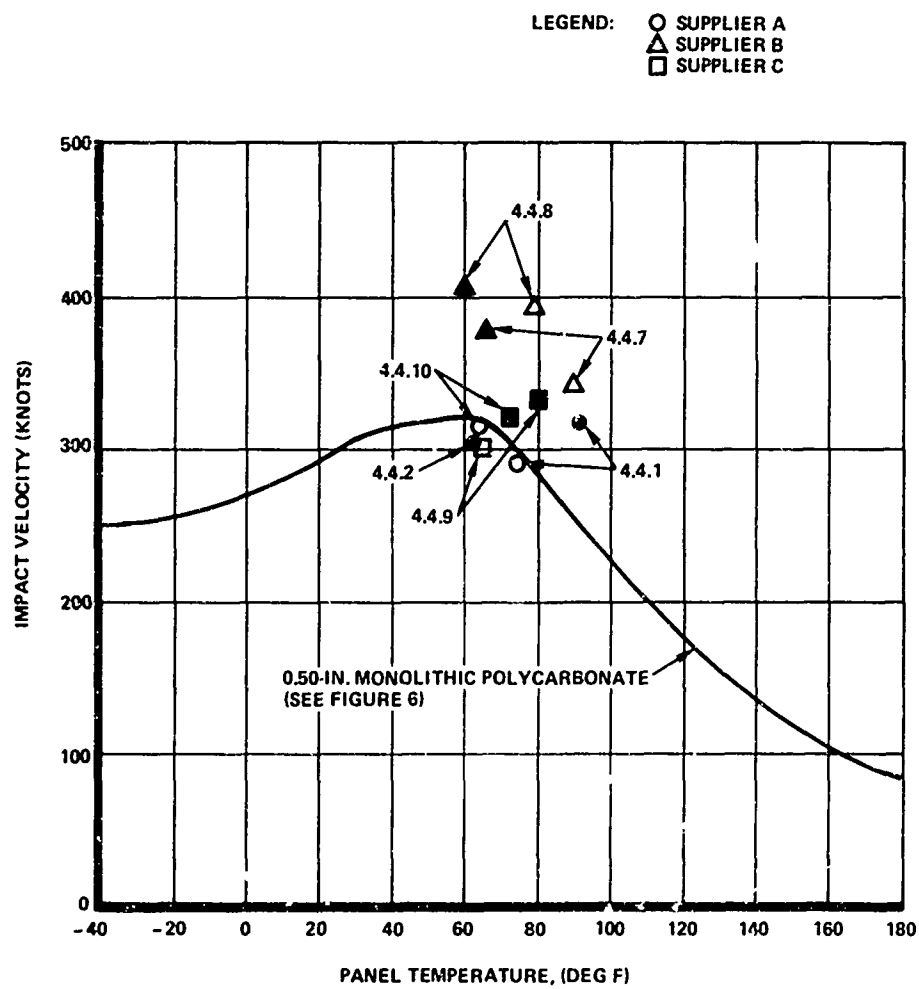
Figure 28. Comparative Test Results for Optically Treated 0.50-In. Monolithic Polycarbonate Processed by Several Suppliers and Tested at 45-Deg Bird Impact Angle

Figure 28 shows the individual panel test results for the 0.50-in. panels together with the curve previously developed from the tests at the 45-deg bird impact angle. The test results for the material furnished by suppliers A and C yielded results essentially the same as during the initial test series. The two panels made from the material supplied by supplier B, however, had penetration velocities approximately 20 to 35 percent higher than these results. The reason for the increased performance of these two panels cannot be clearly established at this time because SL2000-111N material was supplied by supplier B instead of 9030-112 material. The SL-2000 type material is aircraft-quality polycarbonate which differs from the 9030 type material only in that it has slightly better optical qualities, including fewer foreign particles, less pitting and haze, and slightly better light transmission. Structural properties of the two types are essentially identical as confirmed by static tests of both types of material using the excess pieces of each material.

From the results of these tests, it is evident that one of two causes could be responsible for the wide variations in performance. Either the differences between the two types of material influence the bird impact properties, or the processing used by supplier B to effect the fusion bonding provides less structural degradation to the material.

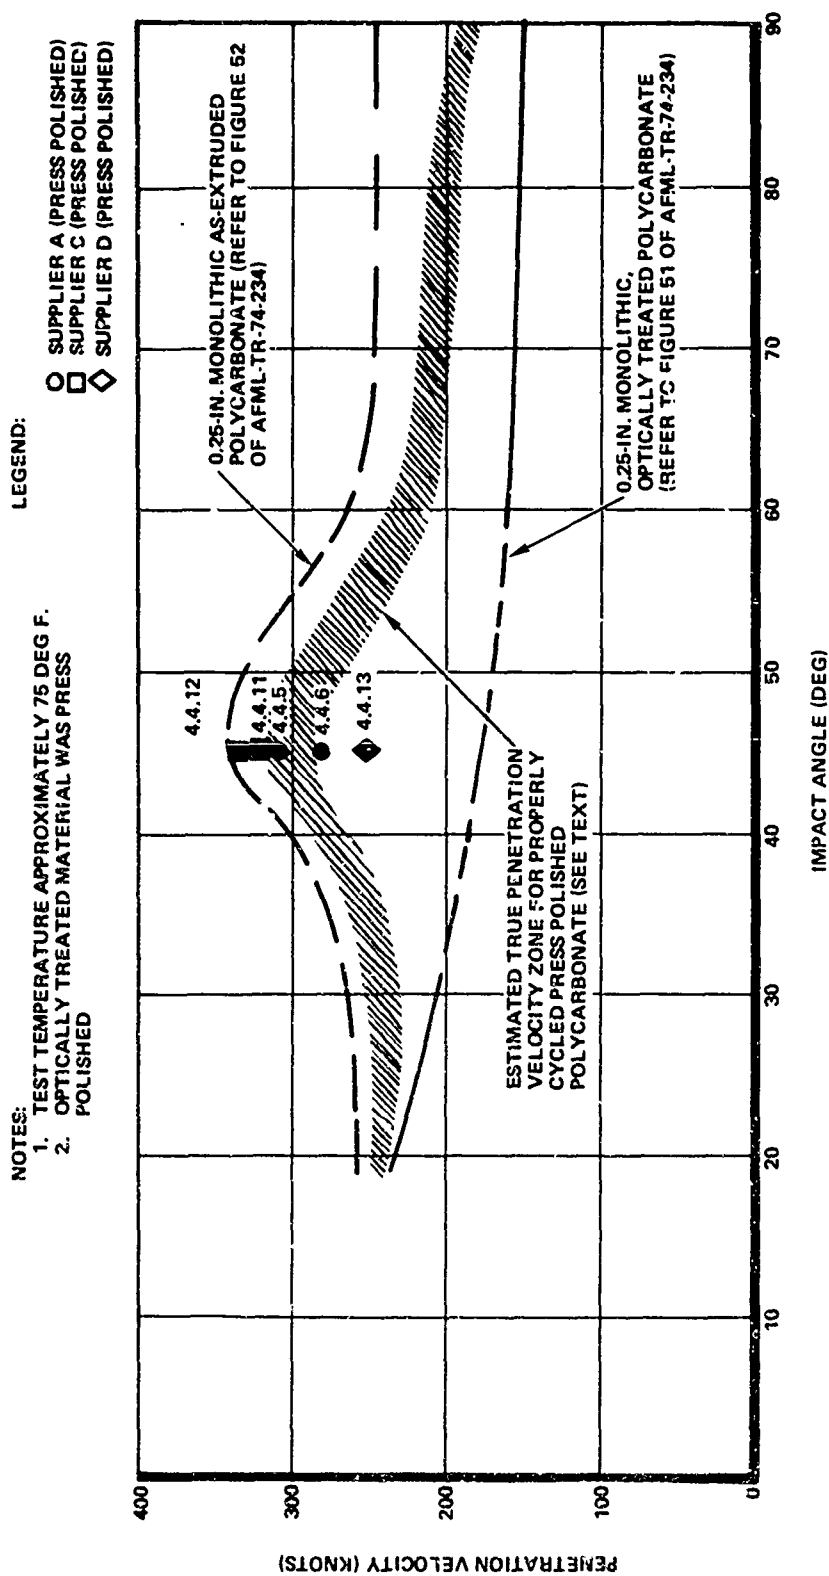
Figure 30. Effect of Bird Impact Angle on Penetration Velocity for Optically Treated 0.25-In. Polycarbonate Processed by Several Suppliers

In an attempt to verify this conclusion, another optically treated specimen (panel no. 4.4.13) was fabricated and tested at the 45-deg impact angle. Unfortunately, this test result, as shown in Figure 30, raises additional questions. The panel failure was again a brittle failure instead of a ductile failure, and the panel failed at a lower velocity than other panels tested at the 45-deg angle. This brittle failure combined with the earlier brittle failures for most of the 0.25-in. panels would seem to point to an improper press-polishing cycle for the 0.25-in. material, leading to excessive degradation of the material elongation characteristics. Without additional specimen testing, the exact penetration velocity for the 0.25-in. optically treated material must remain in doubt. In all probability, the true curve lies between the optically treated and as-extruded curves shown in Figure 30

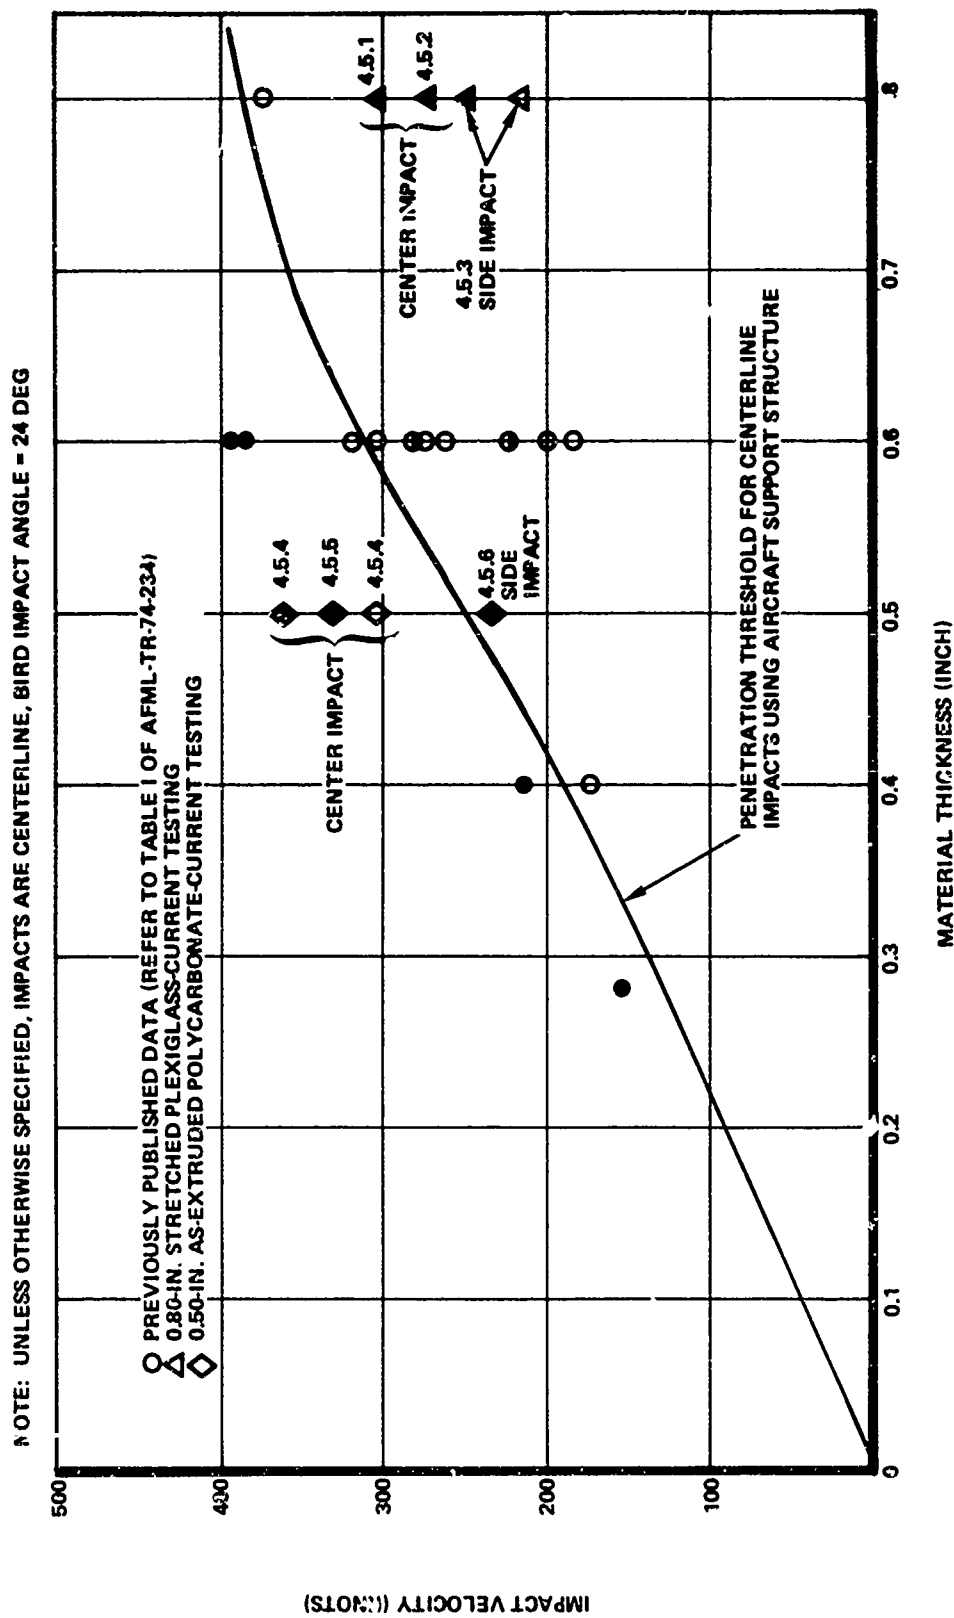
Figure 31. Comparison of Previously Published Data on Monolithic Stretched Plexiglass Windshields with Recent Testing of Monolithic Stretched Plexiglass and As-Extruded Polycarbonate

Figure 31 has been prepared to plot previously published test data to provide a base for comparison of the two configurations tested during this task.

It can be seen from Figure 31 that the test results from this current test series fell somewhat below the results from the previously reported data.

This is attributed to the simplified method of attachment used for the current series, because in all cases, failure originated at the attachment holes (see Figure 32). The previously reported tests, however, used actual aircraft support structure and edge reinforcements along the edges of the acrylic.

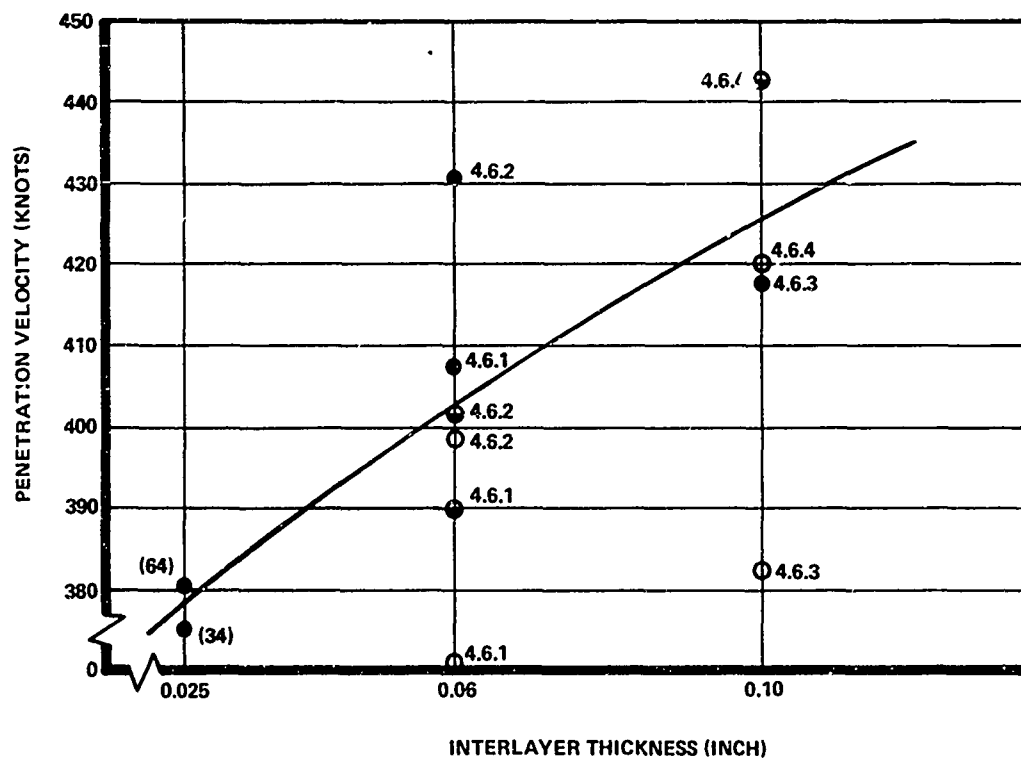
Figure 34. Effect of Ethylene Terpolymer Interlayer Thickness on Penetration Velocity at 45-Deg Bird Impact Angle

The typical failure modes for these panels consisted of cracking of one of the two structural plies at a velocity just below the penetration velocity with penetration of the weakened panel on the subsequent shot.

Cracking would occur in either the front or back ply with no apparent trend to explain the cracking in one or the other. More cracking normally occurred at penetration, but the panels did not shatter. Table 17 summarizes the test results. Figure 34 shows these results plus prior results from AFML-TR-74-234 for the 0.025-in. interlayer thickness. The penetration velocity is seen to increase approximately linearly with increases in the interlayer thickness.

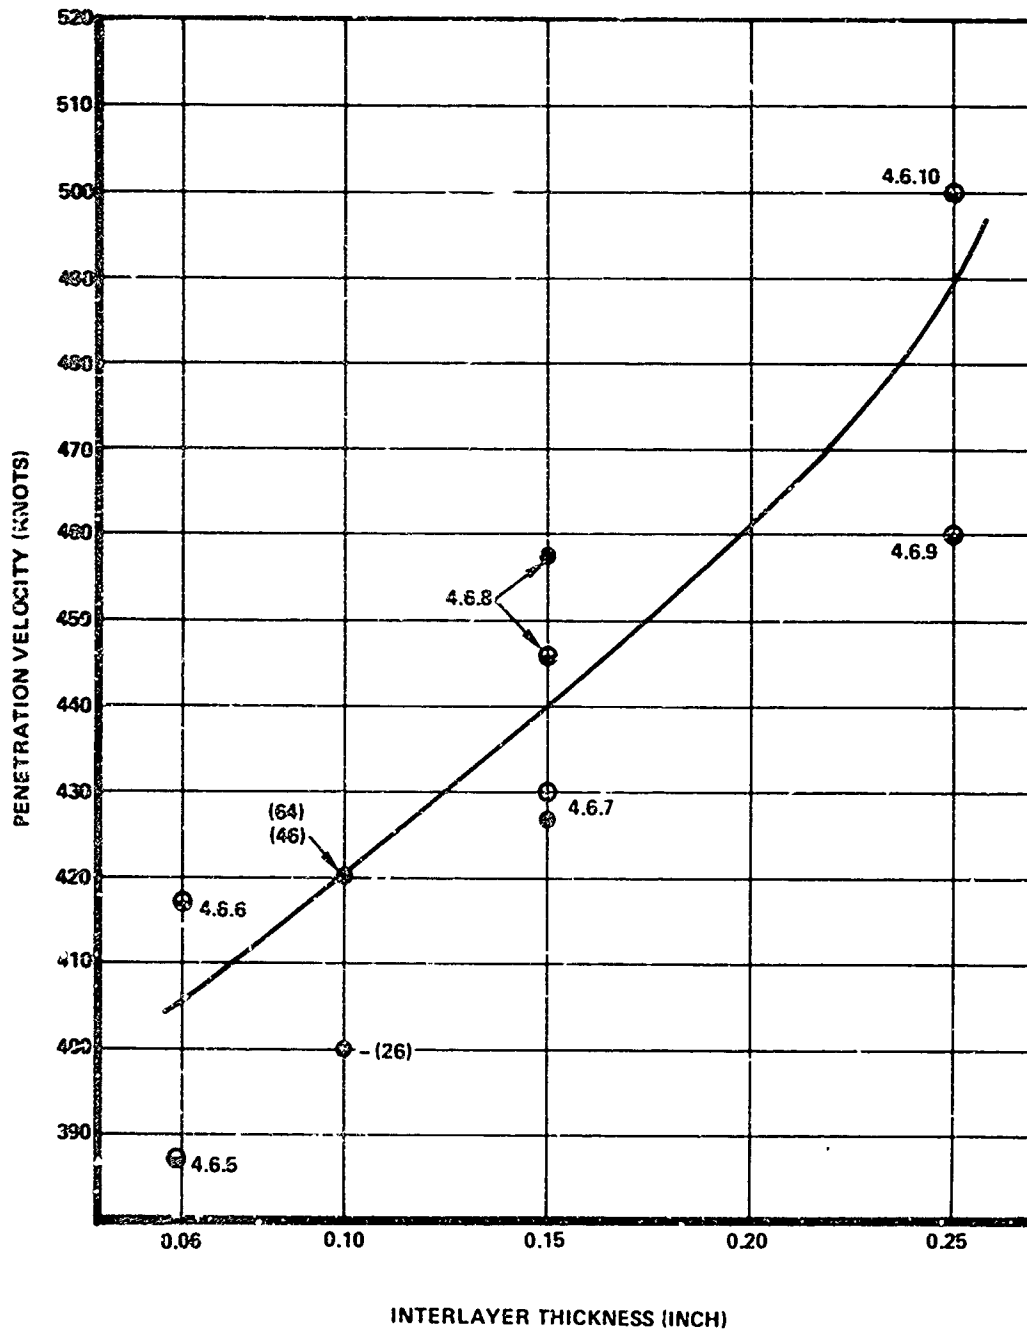
Figure 36. Effect of CIP Urethane Interlayer Thickness on Penetration Velocity at 45-Deg Bird Impact Angle

Table 18 tabulates the test results which are plotted in Figure 36. The data point for the 0.10-in. interlayer thickness was obtained from AFML-TR-74-234. Here again, increasing the interlayer thickness increased the penetration velocity. The slope of the curve tends to become steeper as the interlayer thickness increases.

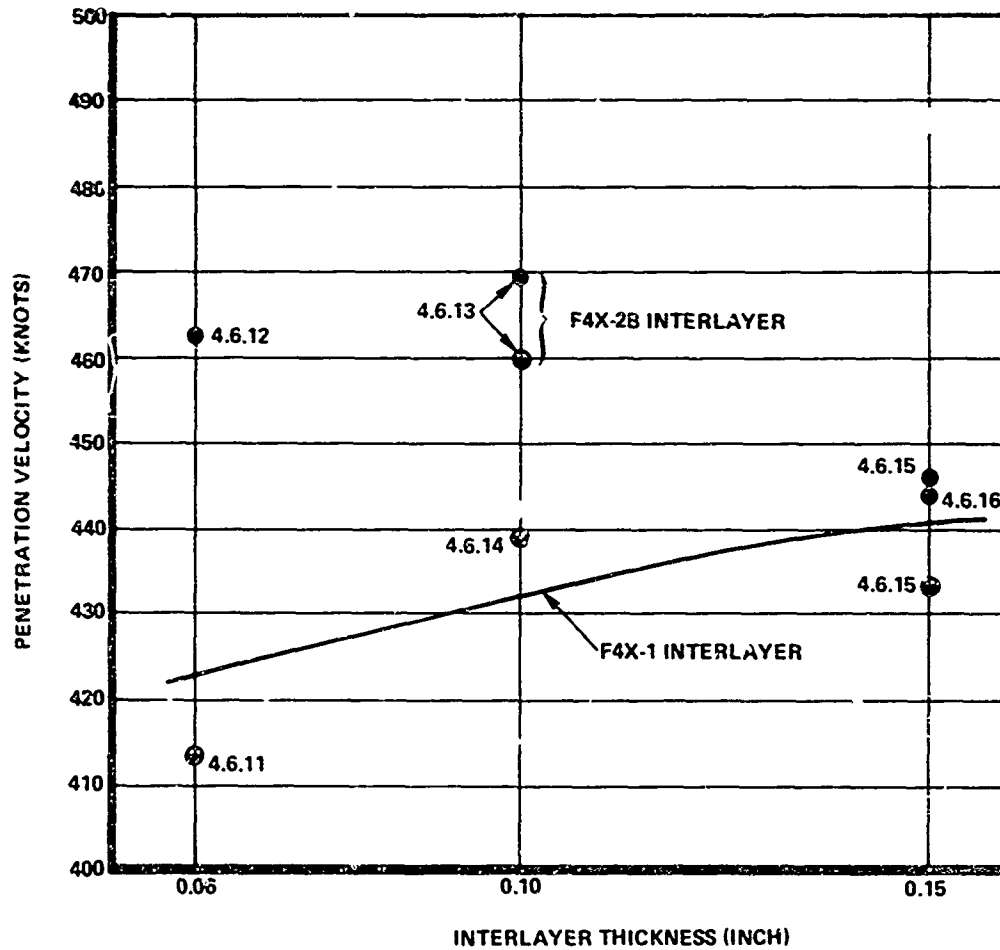
Figure 37. Effect of Silicone Interlayer Thickness on Penetration Velocity at 45-Deg Bird Impact Angle

The test results are tabulated in Table 19 and plotted in Figure 37. Again, increasing the interlayer thickness causes an increase in the penetration velocity, but the rate of increase is less than for the ETP or urethane interlayers. The substantial improvement offered by the modified interlayer can be readily noted.

Failure modes for these test panels were similar to those for the other laminated panels except that the reduced adhesion characteristics of the silicone interlayers were evident in some of the test results. For the thinner interlayers some back face spall was experienced which was not encountered for other interlayers. One test specimen also exhibited some interlayer delamination after testing.

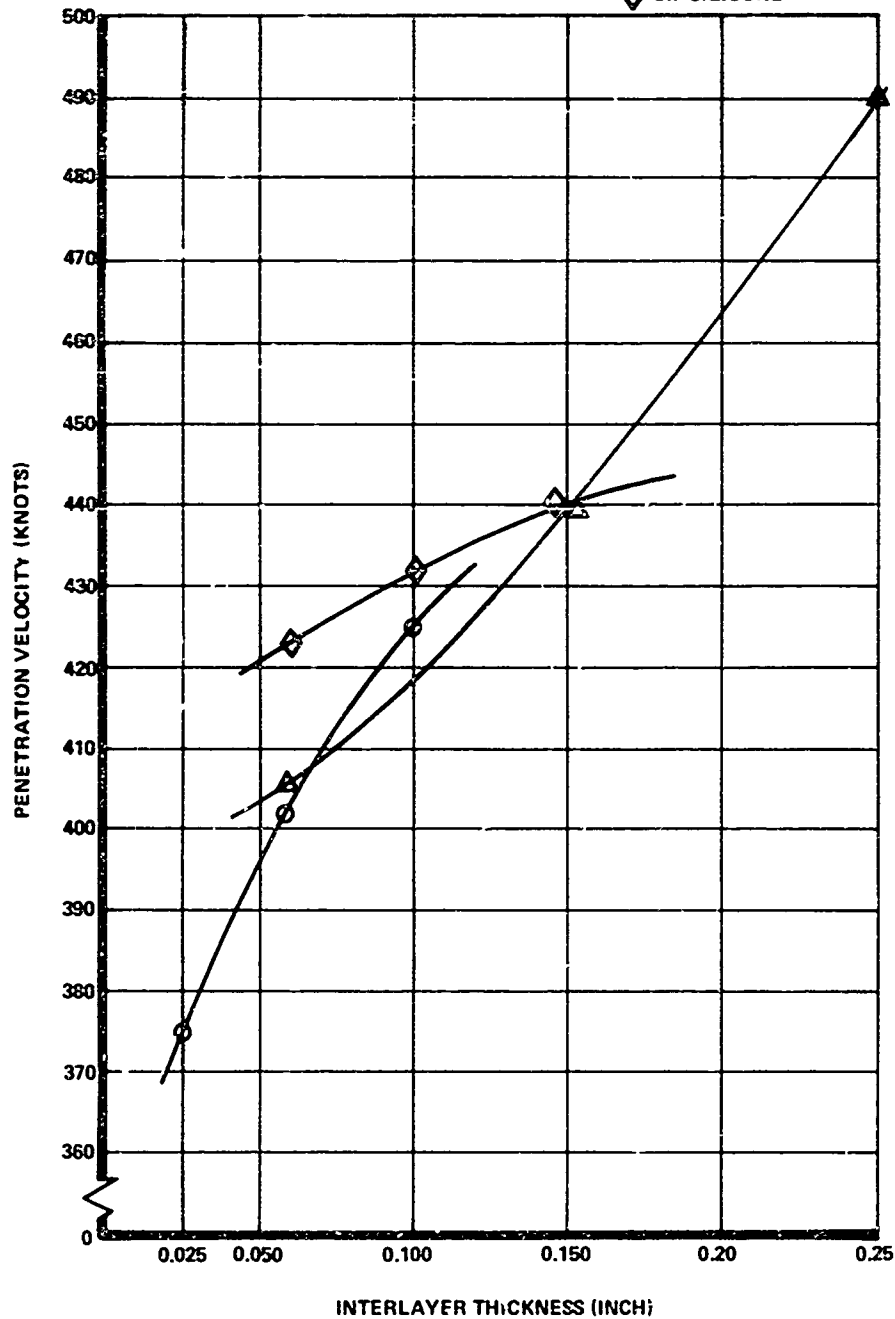
Figure 38. Effect of Interlayer Type and Thickness on Penetration Velocity at 45-Deg Bird Impact Angle

Figure 38 compares the relative performance of the three interlayer types. The ETP sheet interlayer shows lower penetration velocities for 0.025-in. thickness with a sharp increase up to 0.10-in. thickness. The urethane interlayer at 0.06-in. thickness shows essentially the same penetration velocity as ETP with a sharp increase to 0.25-in. thickness. The penetration velocity of the silicone series at 0.06 in. thickness is somewhat higher than both the ETP and urethane interlayers but exhibits a more gradual slope as thickness increases. The tailing off of the silicone interlayer is probably due to the lower tear strength of this interlayer. The increased toughness of both the ETP and urethane interlayers makes them more effective as their thicknesses increase.

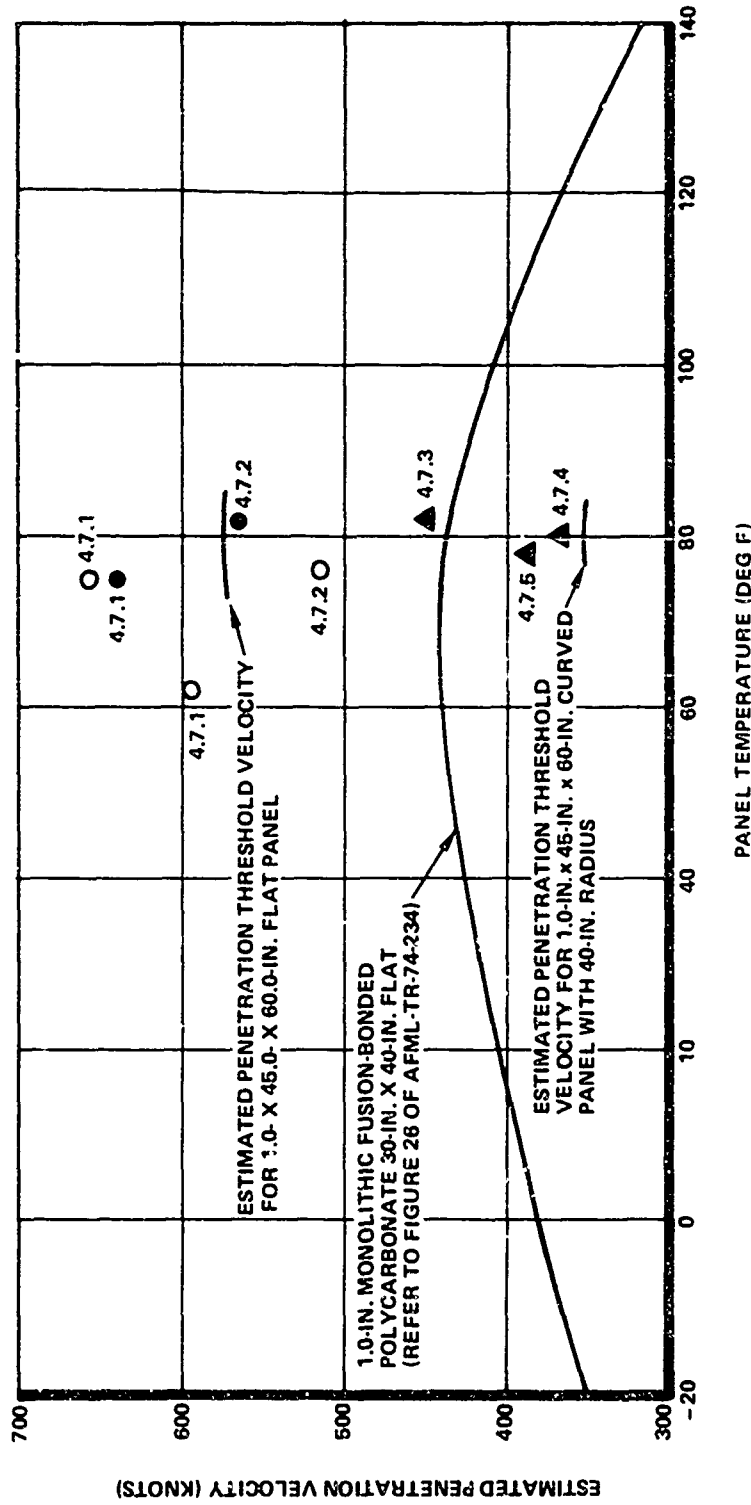
Figure 39. Comparison of Effect of Panel Size on Penetration Velocity of 1.0-In. Monolithic Fusion-Bonded Polycarbonate at 30-Deg Bird Impact Angle

Two panels were tested with panel temperatures ranging from 75 F to 82 F. The results were plotted on the curve previously prepared from standard 30-in. x 40-in. panel tests reported in AFML-TR-74-234 (see Figure 39). As noted in the test summary (Table 20), some breakup of the bird packages occurred before impact on the very high-velocity shots. The main portion of the bird was intact, but in some cases, the outer carton was stripped off by aerodynamic forces. It was estimated that in some cases the weight of the impacting package was perhaps 10 percent or 15 percent below the required 4-pound weight. For this reason, the estimated penetration threshold velocity was reduced from the highest velocities recorded to reflect the effects of the lighter package.

The estimated penetration threshold velocity for the flat 45-in. x 60-in. panel is shown in Figure 39. The penetration velocity for the large panels is approximately 30 percent higher than the penetration velocity for the smaller 30-in. x 40-in. panels at equivalent test conditions.

The test results for the 45-in. x 60-in. curved panels are also shown in Figure 39. Based on prior tests (see Figure 12), it was estimated that the performance of the curved panels would be less than that of the equivalent flat panels. For the 30-in. x 40-in. panels, the 40-in. radius panel had a penetration velocity about 15 percent lower than the equivalent flat panel at 45-deg bird impact angle. Tests of the large panels at even higher reductions of their flat panel penetration velocities still proved to be optimistic with failures occurring on the first hit. However, what seemed to be an excessive amount of bond line delamination of the fusion-bonded plies was noted. It was deemed advisable to obtain a third test panel from an alternate supplier so that the effect of this delamination on the penetration velocity could be determined. Except for the fusion-bonding cycle, all processing, including cutting to size, forming to 40-in. radius and drilling was identical to that performed on the first two panels. The performance of this panel proved no better than the prior two even though no delamination occurred (see Figure 40). Based on these results, it appears that the penetration threshold for the large curved panels is at least 40 percent less than for the equivalent flat panel.

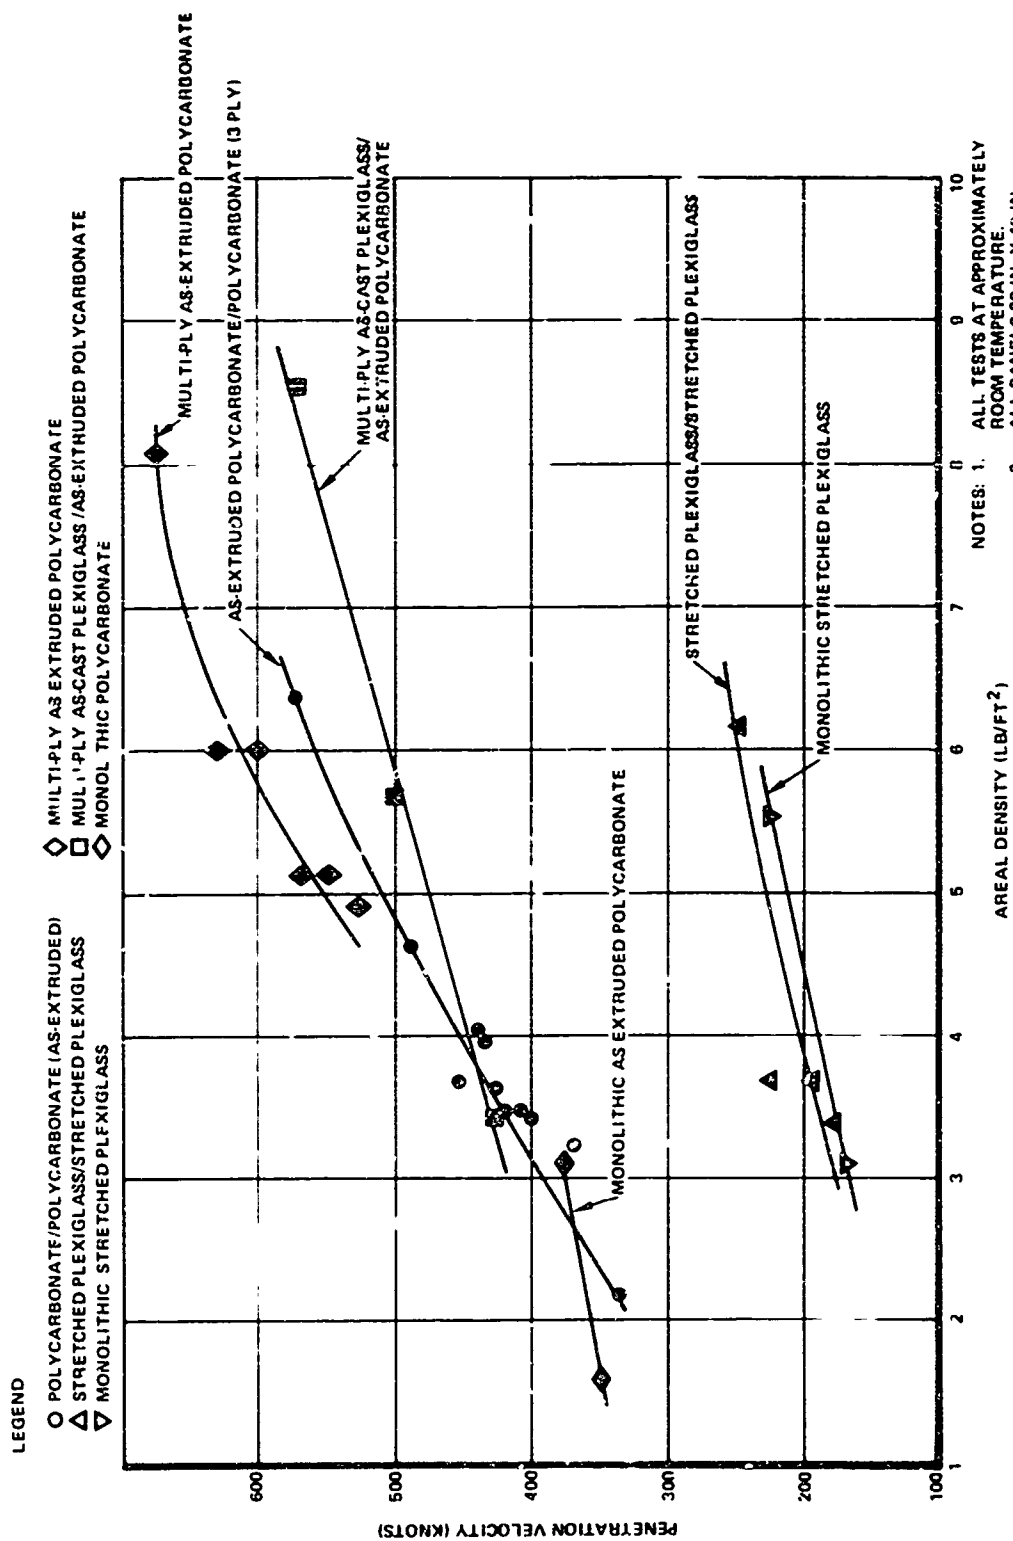
Figure 41. Penetration Velocity versus Areal Density of Flat Laminated and Monolithic Panels at 45-Deg Bird Impact Angle

In the study of armor systems, one of the means to measure the relative performance is to compare the unit weights of each system required to defeat a specific threat. This same concept can be used to establish the relative bird impact performance of the various types of transparency materials and construction methods. Figure 41 presents such a plot based on the tests of the

30-in. x 40-in. flat panels at the 45-deg bird impact angle. The comparative efficiency of each material and construction type can be readily determined from this figure. Monolithic and composite construction types are included. The composites include balanced three-ply laminates and multi-ply (more than three-ply) laminates.
